# Manhole Inspection Summary

Manhole # S33MM1011MH

Insp Date: **2/27/07 5:46 PM**

**Location** Address: **NEIGHBORS PATH**

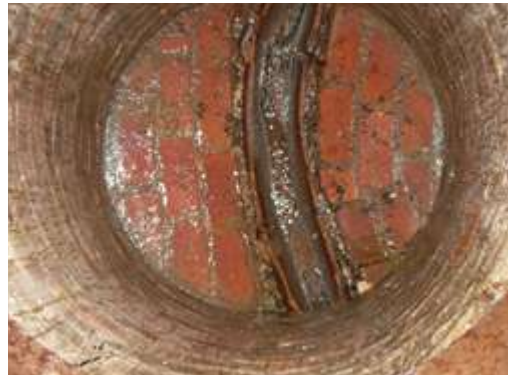
Top View

☐ Parged ☒ **Debris** (not Condition related)

**Surcharge** ☒ **Evidence Of Surcharge** Depth: **1** (ft.) ☐ Active Surcharge Present

Evidence of surcharge - Bench debris.

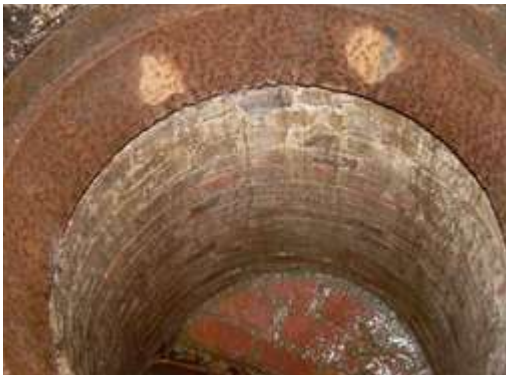
Defect

Condition: ☐ Sound ☐ Cracked ☐ Root Intrusion ☐ Loose Brick ☒ **Deteriorated**

Infiltration: ☐ None ☒ **Joint** ☐ Cracks ☐ Mortar ☐ Roots ☒ **Wall**

Infiltration: ☐ None ☐ Joint ☐ Cracks ☒ **Mortar** ☐ Roots ☒ **Wall**

Corbel deterioration and infiltration. Barrel infiltration.

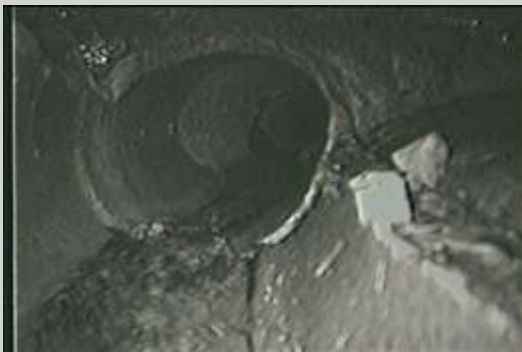
### 6 in. Circular Gravity Sewer Pipe Out @ 12 O'Clock

Deposits: ☒ None ☐ Mud ☐ Sludge ☐ Debris ☐ Grease

Infiltration: **None** Pipe Seal Cond: **Unknown**

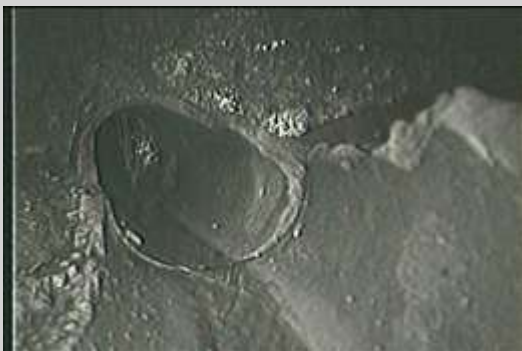
### 6 in. Circular Gravity Sewer Pipe In @ 4 O'Clock

Deposits: ☒ None ☐ Mud ☐ Sludge ☐ Debris ☐ Grease

Infiltration: **None** Pipe Seal Cond: **Unknown**
